# **Spatial and Temporal Assessment of Back-Barrier Erosion on Cumberland Island National Seashore, Georgia, 2011–2013**

Scientific Investigations Report 2016–5071

By Daniel L. Calhoun and Jeffrey W. Riley

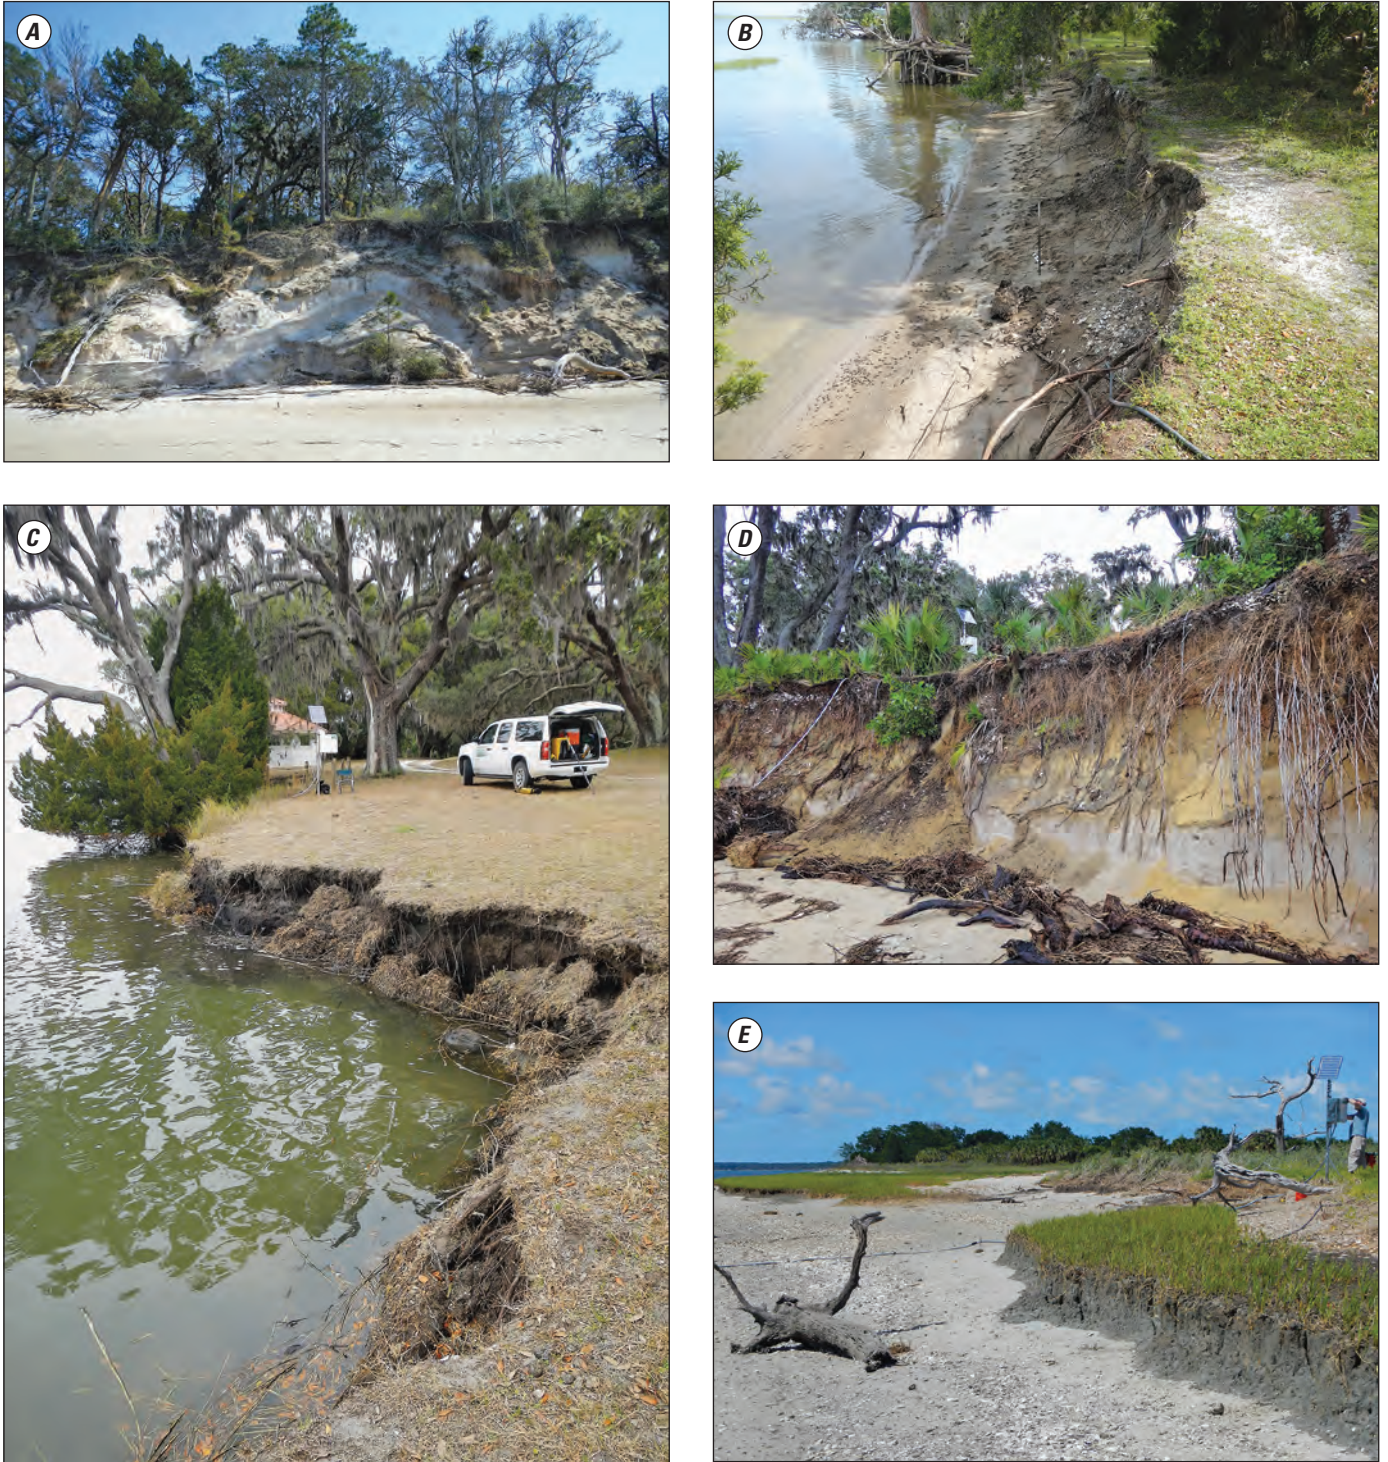
**Figure 3.** Study locations: A, Cumberland Wharf (CW), March 13, 2012; B, Brickhill Bluff (BB), June 20, 2012; C, Plum Orchard (PO), November 8, 2013; D, Dungeness Wharf (DW), November 6, 2012; and E, Raccoon Keys and Marsh (RK), June 19, 2012, Cumberland Island National Seashore.

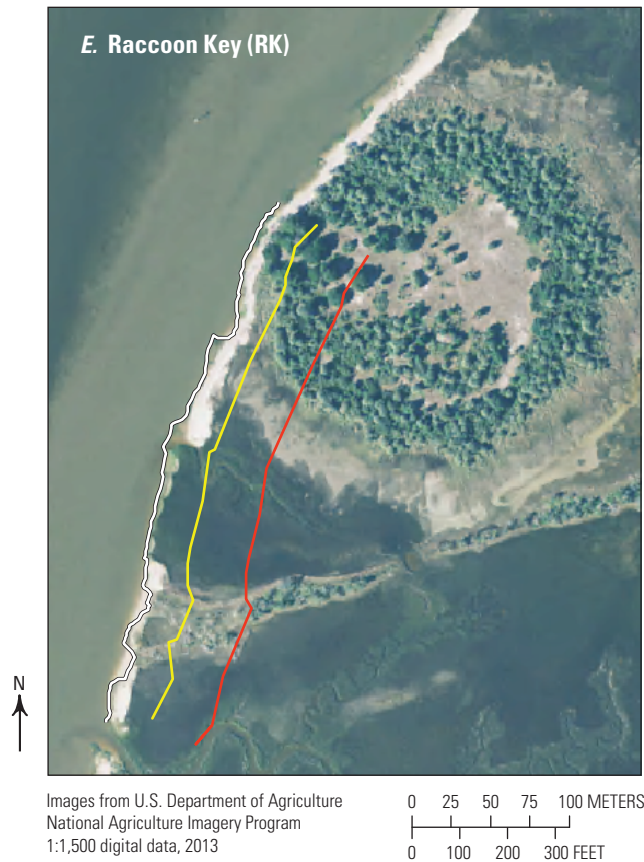
**Figure 8.** Shoreline position in 2013 and projected erosional margins for years 2050 and 2100 along the *A*, Cumberland Wharf (CW) study segment; *B*, Brickhill Bluff (BB) study segment; *C*, Plum Orchard (PO) study segment; *D*, Dungeness Wharf (DW) study segment; and *E*, Raccoon Key (RK) study segment, Cumberland Island National Seashore. Positions were based on rates of change determined in this study; the 2013 survey is the beginning position. Hardened or armored structures currently in place were not taken into account in these estimations. See figure 1 for locations.

**Figure 8.** Shoreline position in 2013 and projected erosional margins for years 2050 and 2100 along the *A*, Cumberland Wharf (CW) study segment; *B*, Brickhill Bluff (BB) study segment; *C*, Plum Orchard (PO) study segment; *D*, Dungeness Wharf (DW) study segment; and *E*, Raccoon Key (RK) study segment, Cumberland Island National Seashore. Positions were based on rates of change determined in this study; the 2013 survey is the beginning position. Hardened or armored structures currently in place were not taken into account in these estimations. See figure 1 for locations.—Continued

When using the erosion rates observed in this study to extrapolate future shoreline position, results indicate an average retreat (across all monitored locations) of 15 m by 2050 and approximately 37 m by 2100. The projected positions of these margins—overlying aerial photographs of the locations—are included in figures 8A–E. As stated previously, these values should be interpreted cautiously, should be used only for assessing potential vulnerability, and should not be viewed as absolute positions because the rates are likely spatially and temporally variable. To put these erosion rates into a wider context, the rates were compared with those in corresponding zones in Jackson (2006). When compared to long-term retreat estimated by averaging the long-term erosion rates (about 132 years) of each zone reported in Jackson (2006), mean retreat in the Jackson study is quite similar to the results of this study, with a margin retreat of 15 m and 35 m, respectively, over the 37- and 87-year periods that correspond to 2050 and 2100, respectively. While the results of this study are in agreement with past observed retreat, the dynamics that are likely responsible and even discrete locations of erosion within these zones have likely shifted over time as promontories have eroded and energy has been shifted laterally across the margin face. Erosion rates measured in the present study are similar to those estimated over much longer time periods and may represent change during average and ongoing conditions.

Cumberland Wharf (CW) does have an extensive strandplain feature, as is shown in figure 8.4. The material that forms the strandplain appears to be delivered, at least in part, from the extensive bluff slumping that was observed there. Storm tides appear to be reaching the base of the margin at CW, undercutting the bluff, and leading to further slumping. Continuous measurements were not collected at the CW site, as has been noted above, preventing any attribution of the timing of the change. However, the average annual rate of retreat of the top of the margin (table 2) is close to that measured at DW, which was most similar among the study sites—in both matrix material and profile—to CW.
